**2-SPENT CATALYST STANDPIPE EXPANSION JOINT**  
MUNRO & MILLER DWG N° 1F 5115 B/1C      **EJ 102 (1982)**

**2.2 ULTRASONIC CHECKING OF BELLOWS THICKNESS**

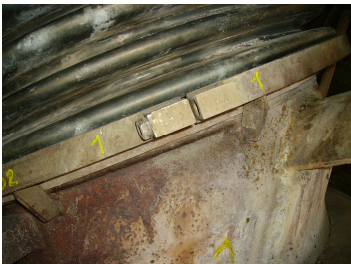
*The first reinforcing must be not removed*

*Control nuts removed*

*Spring hanger removed without block EJ*

**It will be ABSOULTLY necessary to replace this Expansion joint by a new spare part.**
